# A maintenance revolution for the UK - update

**Plasser UK's Mark Simmons details the latest on the Robel mobile maintenance system for Network Rail.**

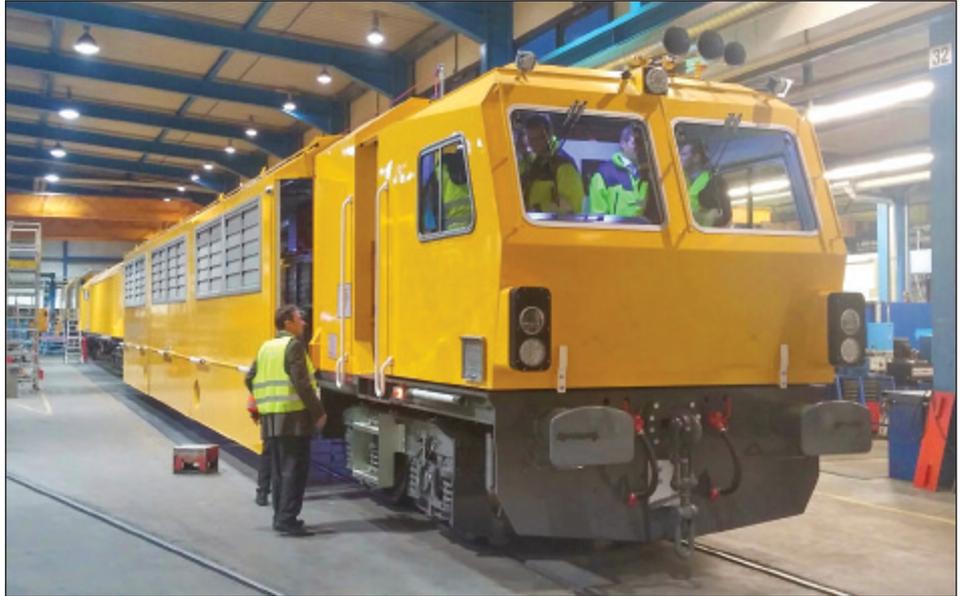
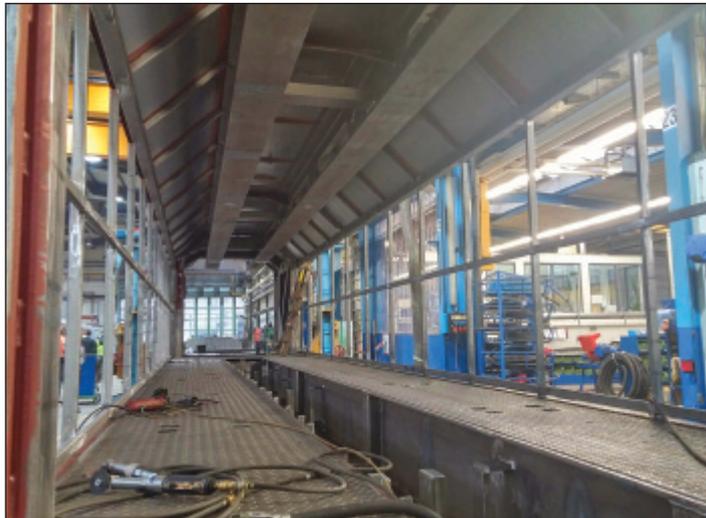
As can be seen from the photograph (right) in the workshop, all three parts were connected in time for the visit. The eagle-eyed may notice though that the Traction Supply Unit (TSU) section, pictured at the rear, still required a little further work under the floor and so the body was raised slightly relative to the Intermediate Car (IC).

The IC (pictured above) is the furthest advanced with the superstructure already in place on top of the frame. The TSU frame is pictured below upside down. It will spend quite some time in that state while the pneumatics and hydraulics are fitted. In the meantime, the mess-room, engine-bay and mini-workshop cabin can be seen ready for painting (above right). Even Mobile Maintenance Unit (MMU) number two is underway. Pictured below right,

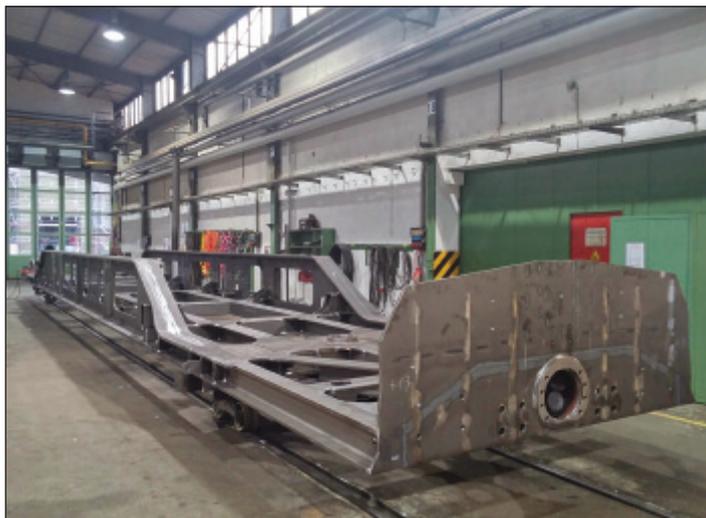
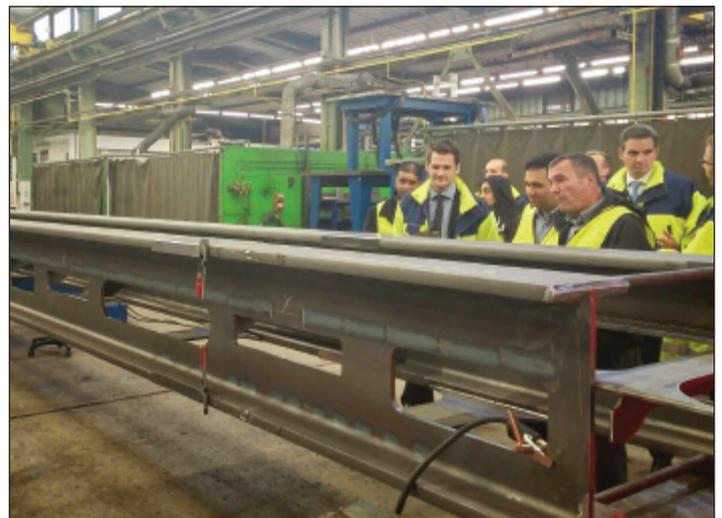
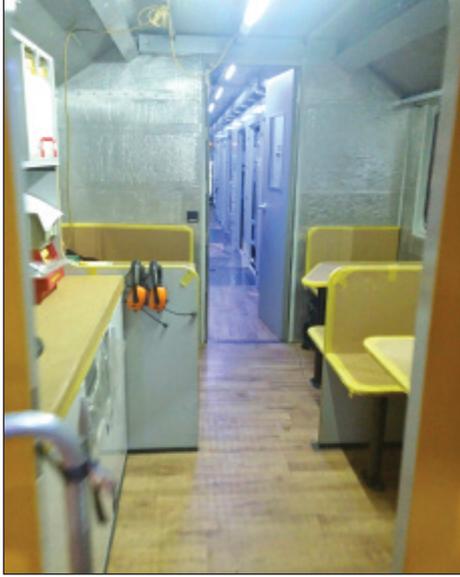
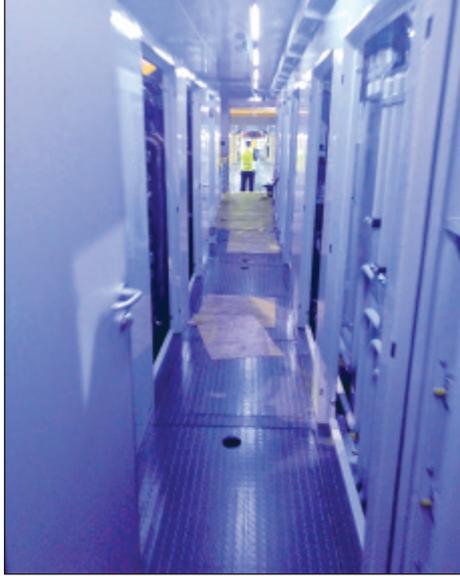
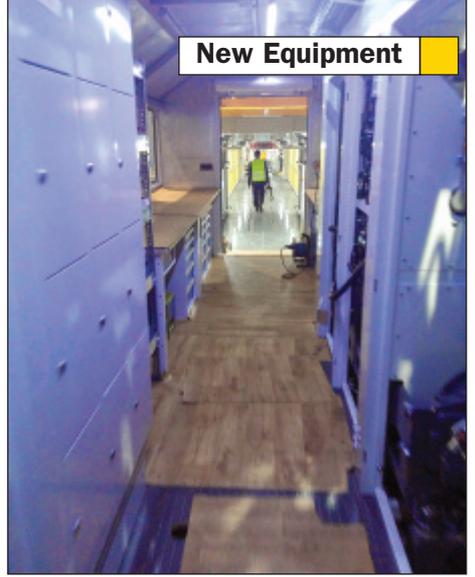
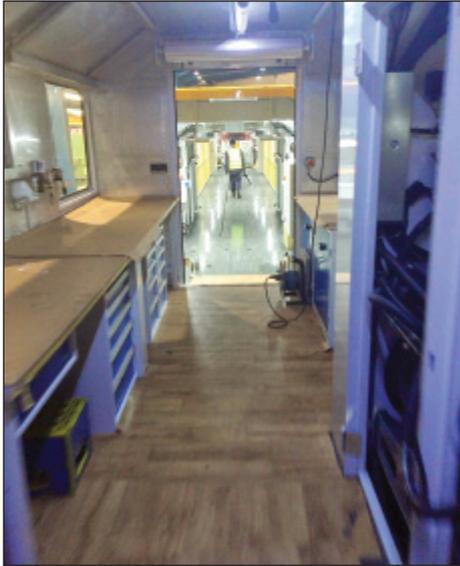
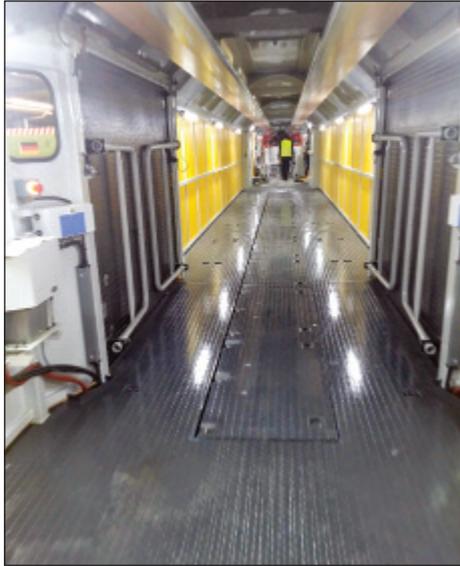
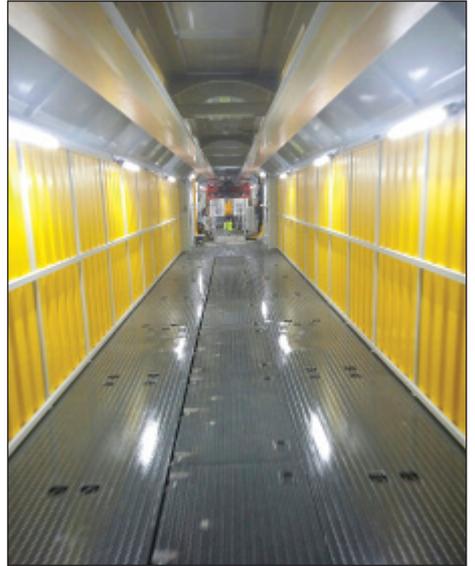
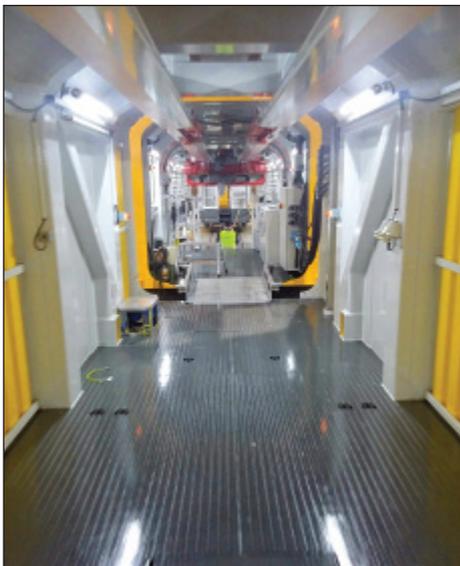
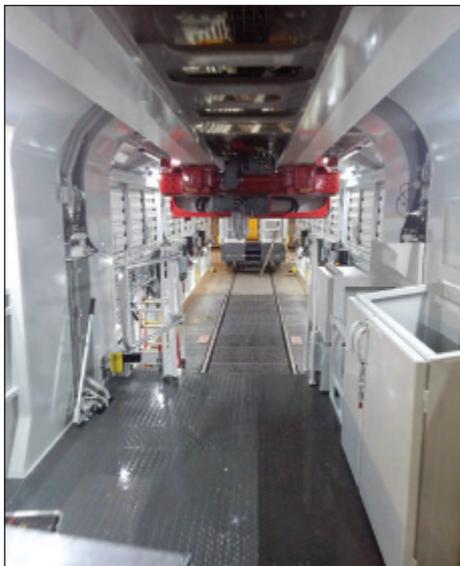
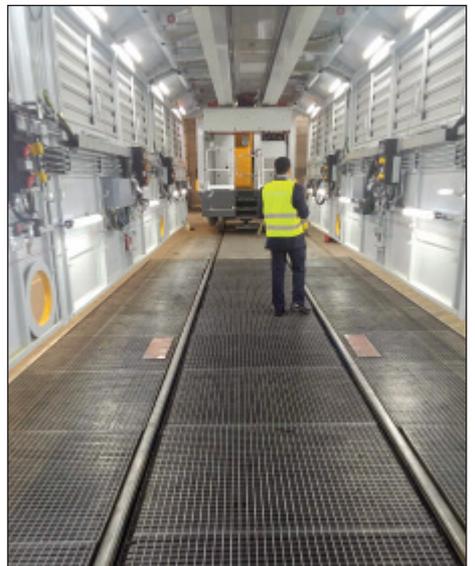
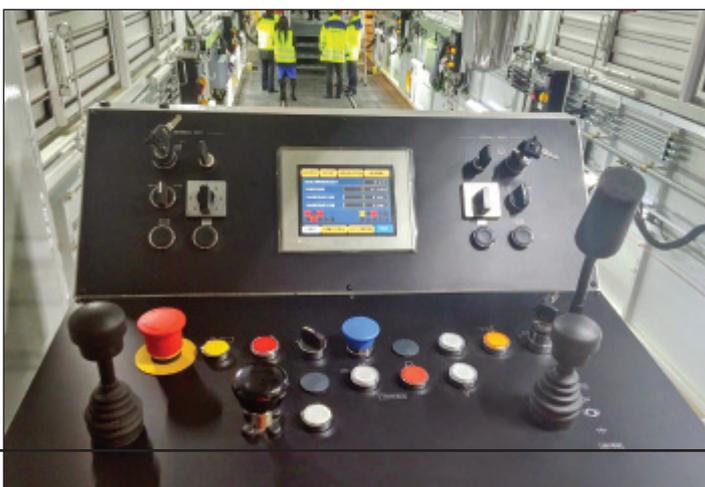
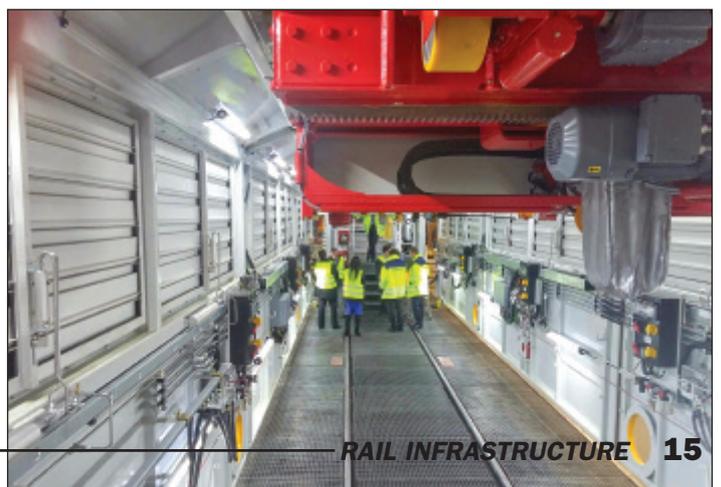
Arriving at the machine in the workshop, in the evening after the shift was complete, gave the inspection team an opportunity to view the inside of the system from end-to-end. The series of photographs on page 15 walk through the system from the TSU messing area, past the toilet, through the corridor into the mini-workshop at the end of the TSU and

into the IC.

Here, you can see the side-lift doors and the storage area and, in the far distance, the platform on the MMU with the gas storage area and steps leading down to the track level in the MMU. Closer up you can see the lifting hoist in the MMU over the track access and the view from track level. Finally, climbing up the stairs at the end and turning around a view from there and of the MMU operator's panel.

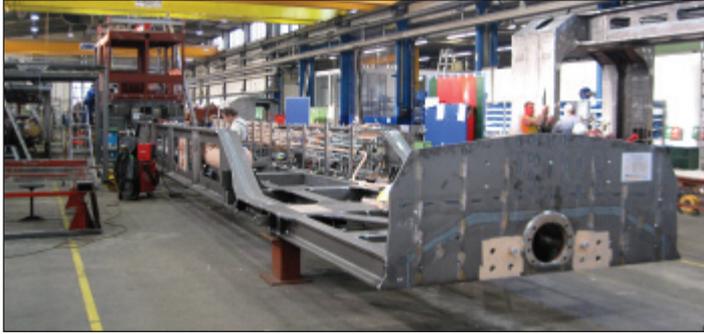
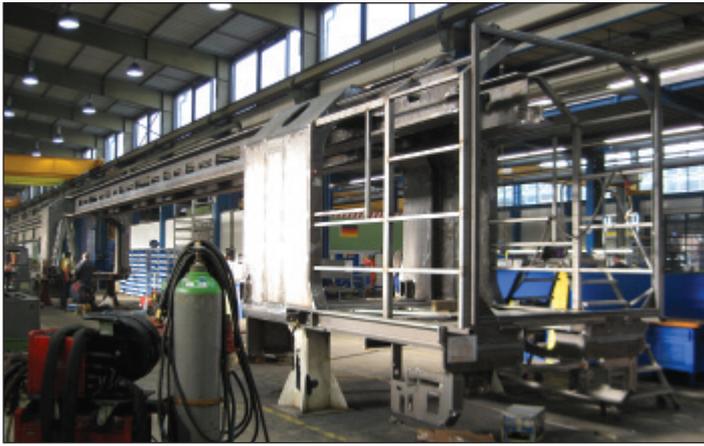
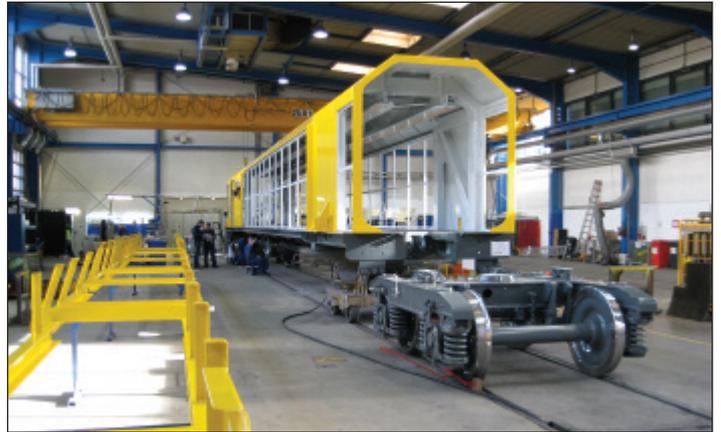
With such significant progress since the last update, I had anticipated finishing there. However, the next meeting focusing on the small plant to be used inside the MMU took place in the middle of January. By this time, the structure of the second IC had been painted (right), pneumatic installation had begun on the second TSU frame (below) and the second MMU had gone from a couple of I-beams to a machine frame (bottom).

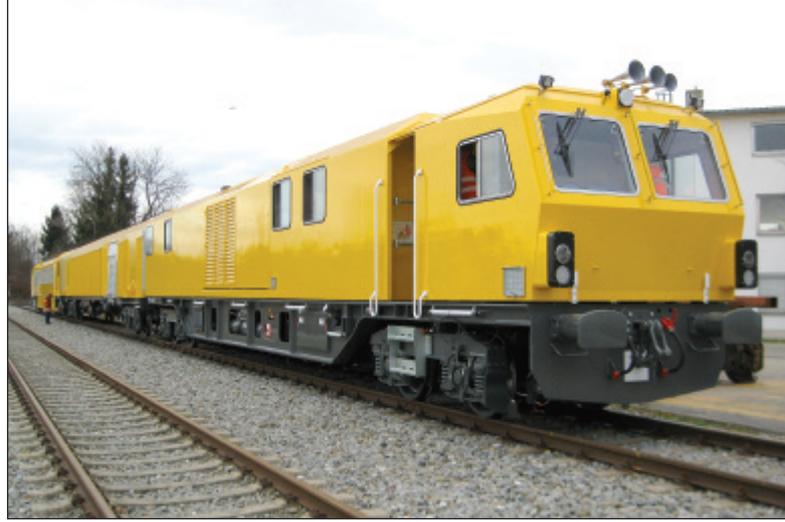
The highlight though was the first MMS (below), engine started, now out of the workshop and moving up and down the test track!
